STRUCTURAL INTEGRITY RESERVE STUDY

The Fountain Tower Condominium Association, Inc.

7118 Bonita Dr., Miami Beach, FL 33141

Inspected on: May 14, 2025

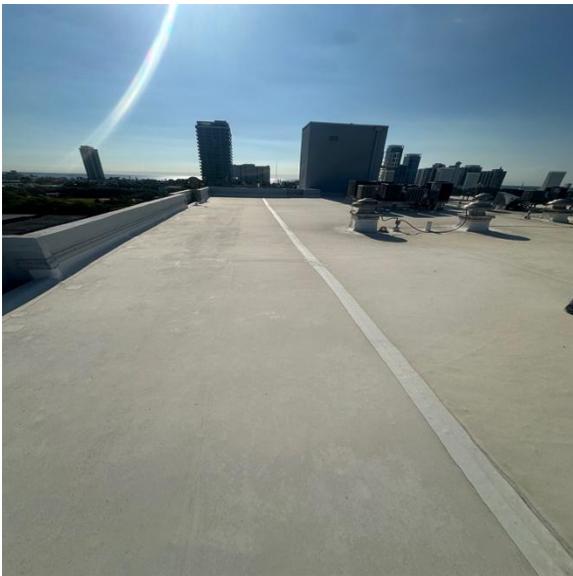
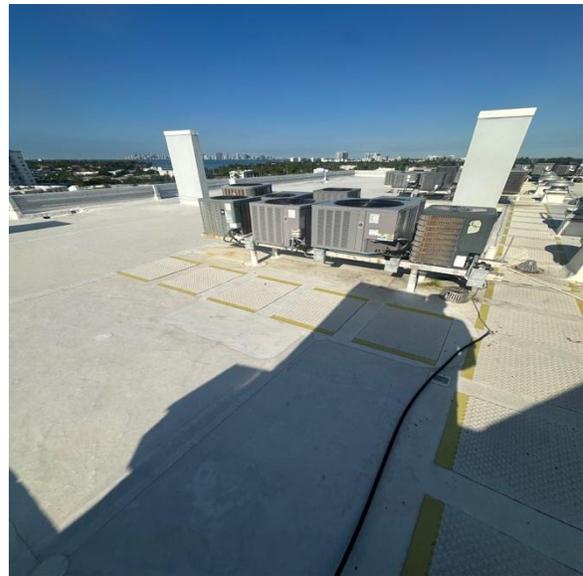
Condition: The roof is in satisfactory condition.

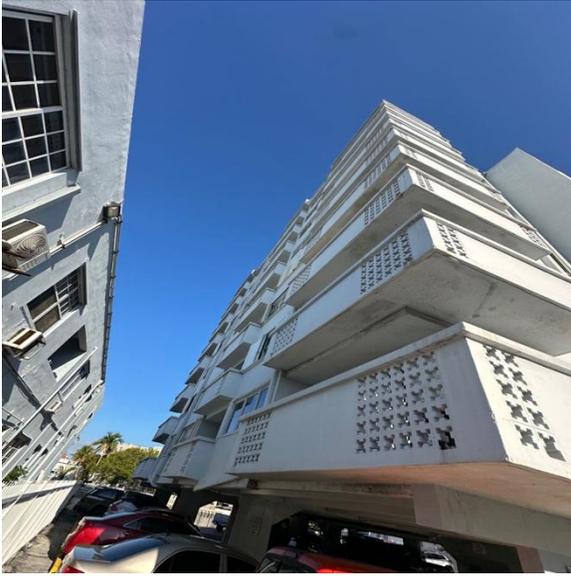
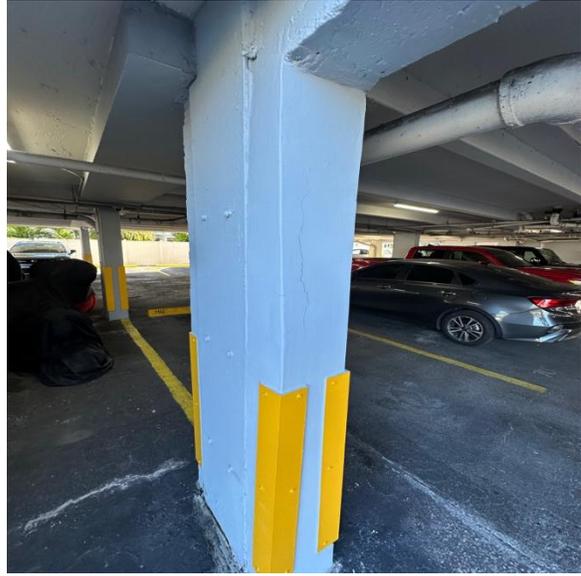
Condition: The concrete framing and floor systems is in unsatisfactory condition.

Remaining Lifespan: Although concrete is a very durable material, due to the location's proximity to the coast, spalling due to rebar corrosion usually manifests before the concrete naturally deteriorates. It is important to note that it is rarely possible to visually inspect and examine all the concealed construction, nor should be generally necessary. Our conclusions are based upon our experience and conditions examined in the exterior typical structural members of the building. Refer to the table presented at the end of this report.

Estimated Cost of Replacement: Concrete repairs are typically done on a unit-price basis and should be repaired as damages appear. Refer to the table presented at the end of this report for our recommendation based on our experience and the size of the building.

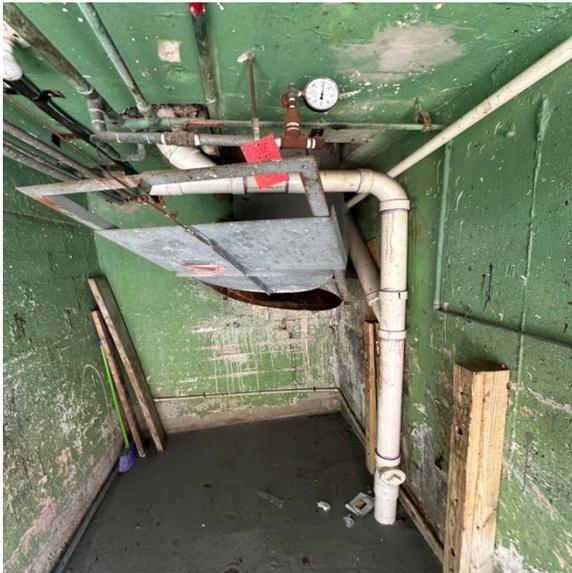
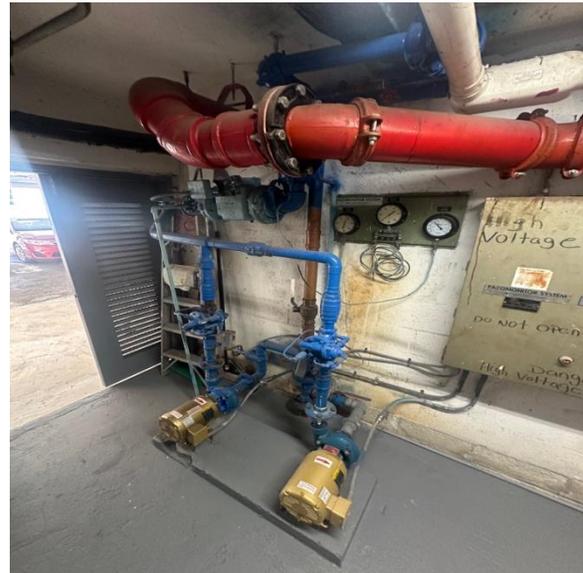
Condition: The plumbing system is in satisfactory condition. It is important to note that it is rarely possible to visually inspect and examine all the concealed construction, nor should be generally necessary. Our conclusions are based upon our experience and deficiencies found in the visible and readily accessible areas.

Estimated Cost of Replacement: Plumbing lines and systems are typically not replaced in their totality but are repaired as items appear. See the table presented at the end of this report for our recommendation based on our experience and the size of the building.

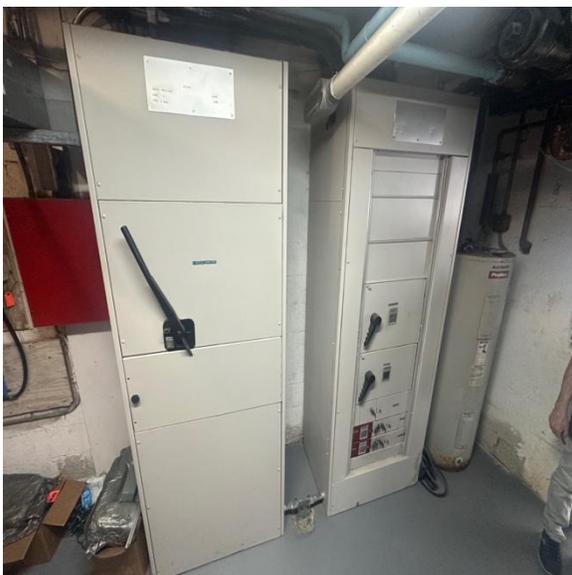
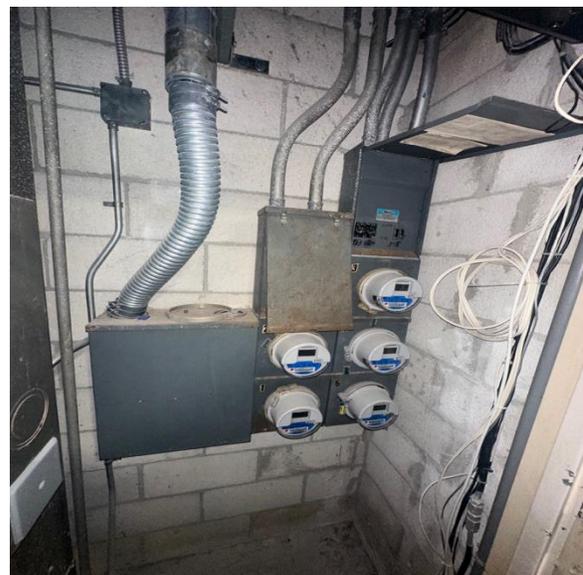
Condition: The electrical system(s) is in satisfactory condition.

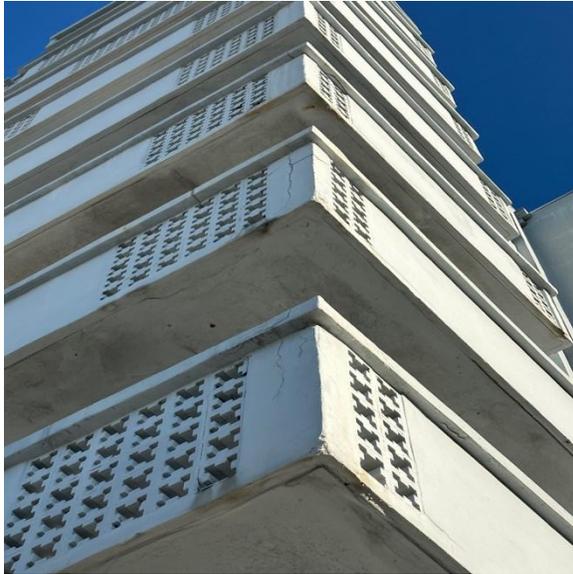
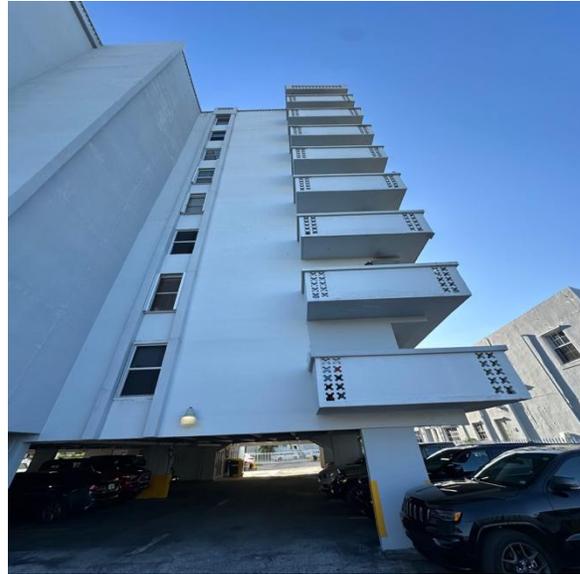
Condition: The exterior stucco is in unsatisfactory condition. It is important to note that our conclusions are based upon our experience and deficiencies found in the visible and readily accessible areas.

Remaining Lifespan: Although the stucco is a very durable material, due to the location's proximity to the shore, spalling due to rebar corrosion usually manifests before the stucco naturally deteriorates. Refer to the table presented at the end of this report.

Estimated Cost of Replacement: The removal and replacement of all the stucco finish is rarely required. It is typically repaired as required in the building for general maintenance. Therefore, we assume that 20% of all exterior surfaces are required to be replaced at once. See the table presented at the end of this report for our recommendation based on our experience and the size of the building. (The exact amount of area needing replacement will be discretionary based on the actual future conditions and the desired appearance).

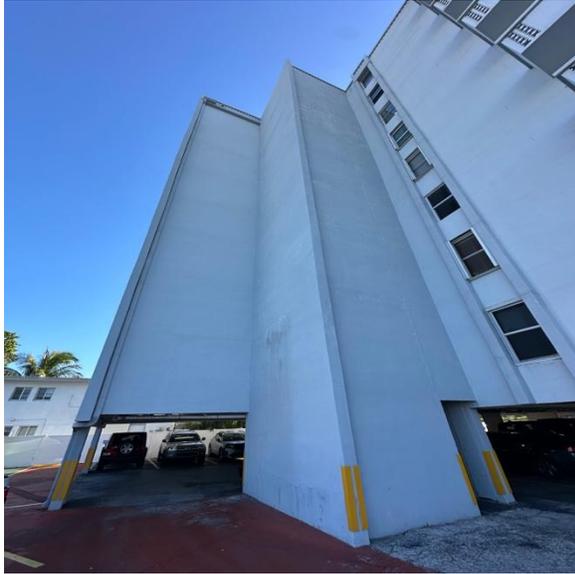
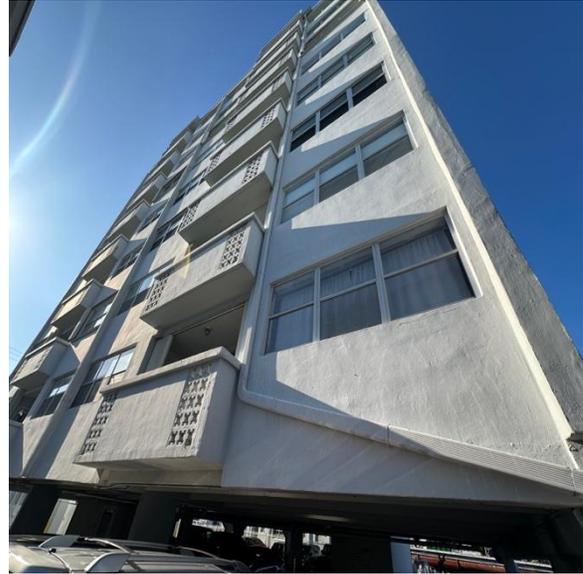
Condition: The surfaces appear to be in unsatisfactory condition.

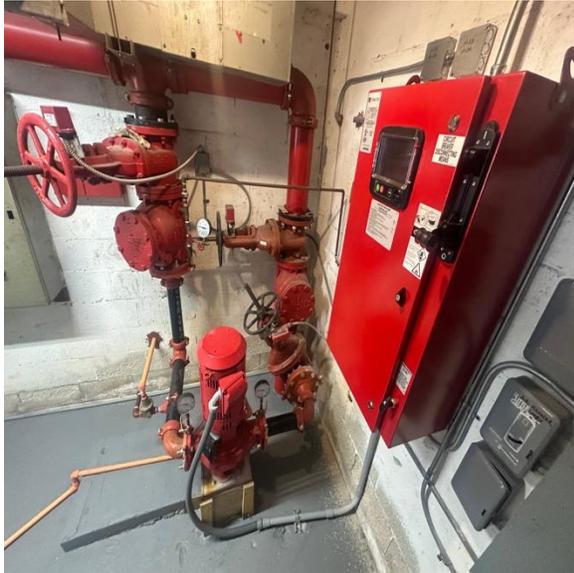
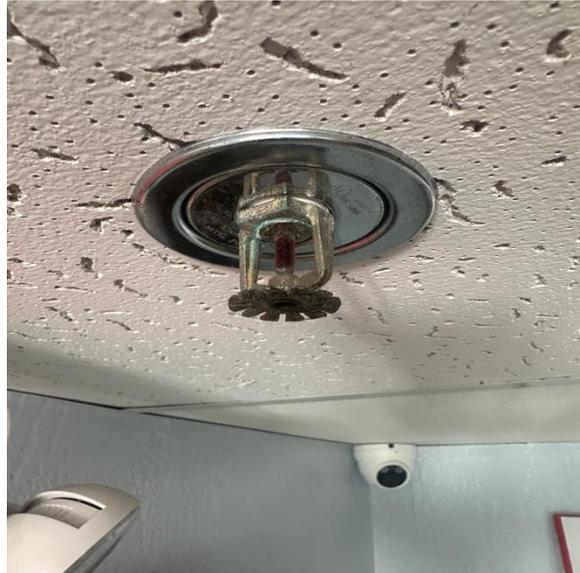
Condition: The fire protection systems appear to be in satisfactory condition.

Estimated Cost of Replacement: Fire protection systems such as the ones observed in the building are typically not replaced in their totality but are replaced as required. See the table presented at the end of this report for our recommendation based on our experience and the size of the building.

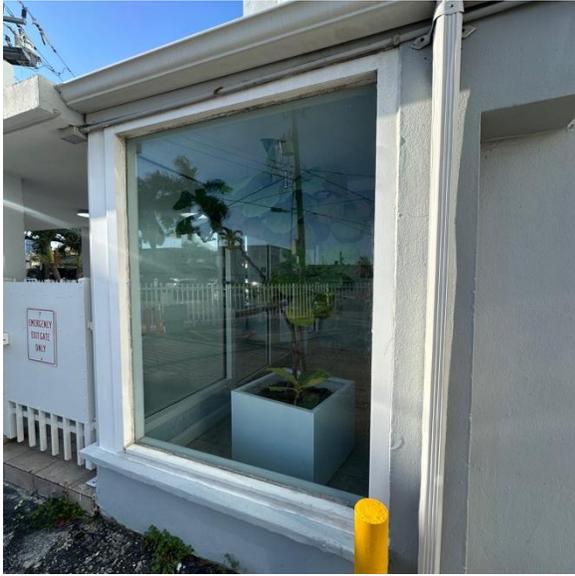
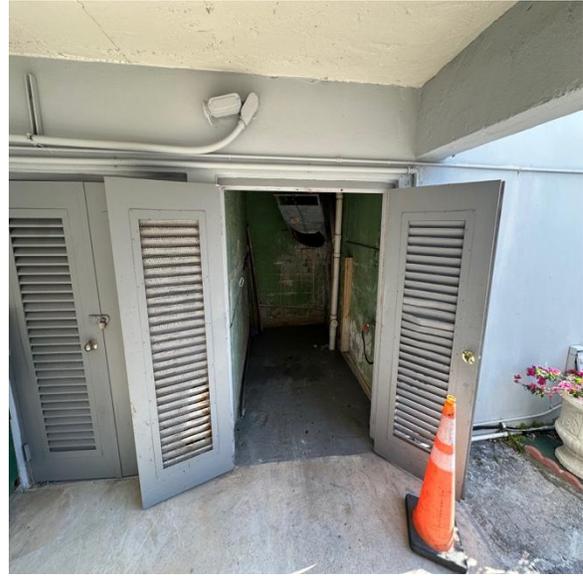
Condition: The common area windows and doors appear to be in satisfactory condition. The association is only responsible for the common areas. The units' windows and doors are the unit owner's responsibility.
